MISCELLANEOUS PAPER NO. 4-759

# EVALUATION OF U. S. STEEL TYPE 4.5 AIR-DEK LANDING MAT

November 1965

**U. S. Army Engineer Waterways Experiment Station  
CORPS OF ENGINEERS  
Vicksburg, Mississippi**

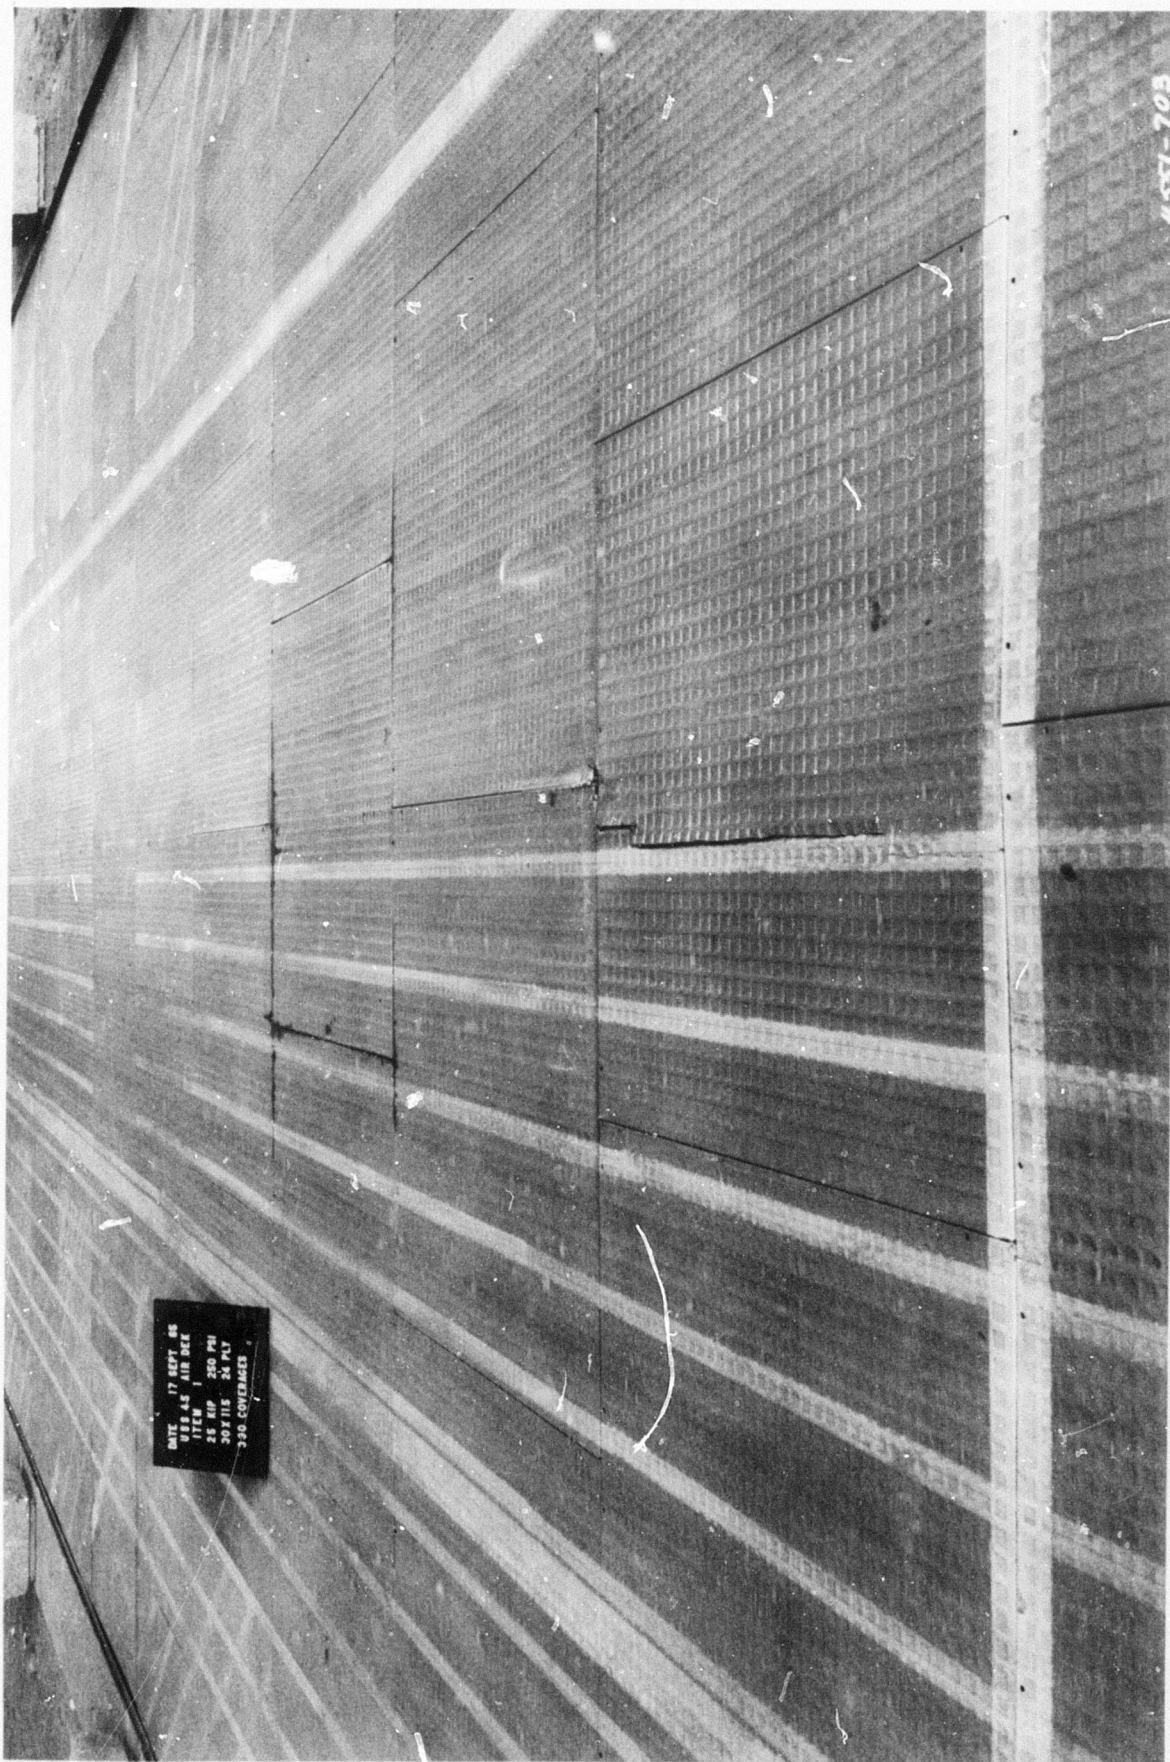
21. Traffic was concluded at completion of 330 coverages as panels 31 and 34 failed (see photograph 13) because breaks had increased to the point of producing tire hazards. A general view of the section at failure is shown in photograph 14.

Photograph 13. Close-up of panel failures in item 1 after 330 coverages

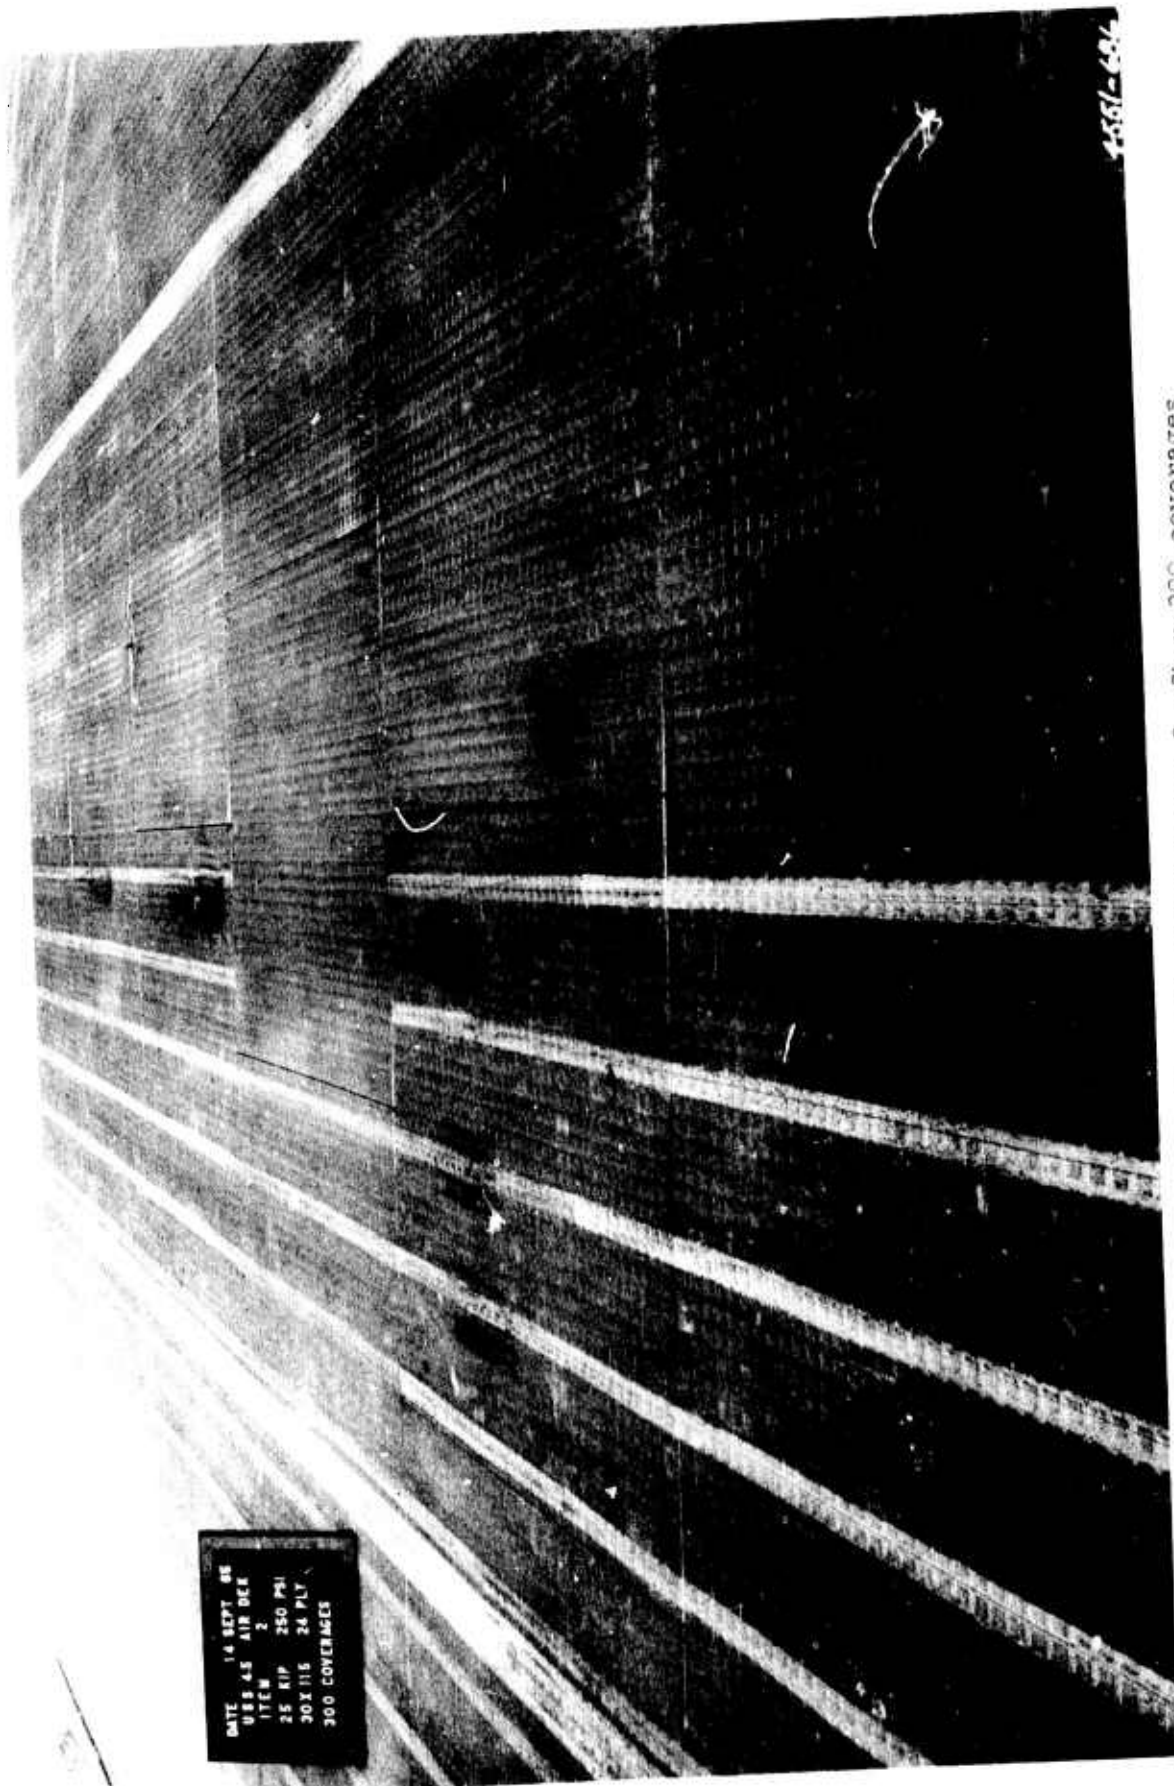
failure in panel 48 was extended to an area of a circle 10 in. in diameter. The overall section remained relatively smooth at this time as shown in photograph 18. Panel 48 was removed and repaired at 206 coverages due to core-to-facing bond failure.

Photograph 18. Item 2 after 200 coverages

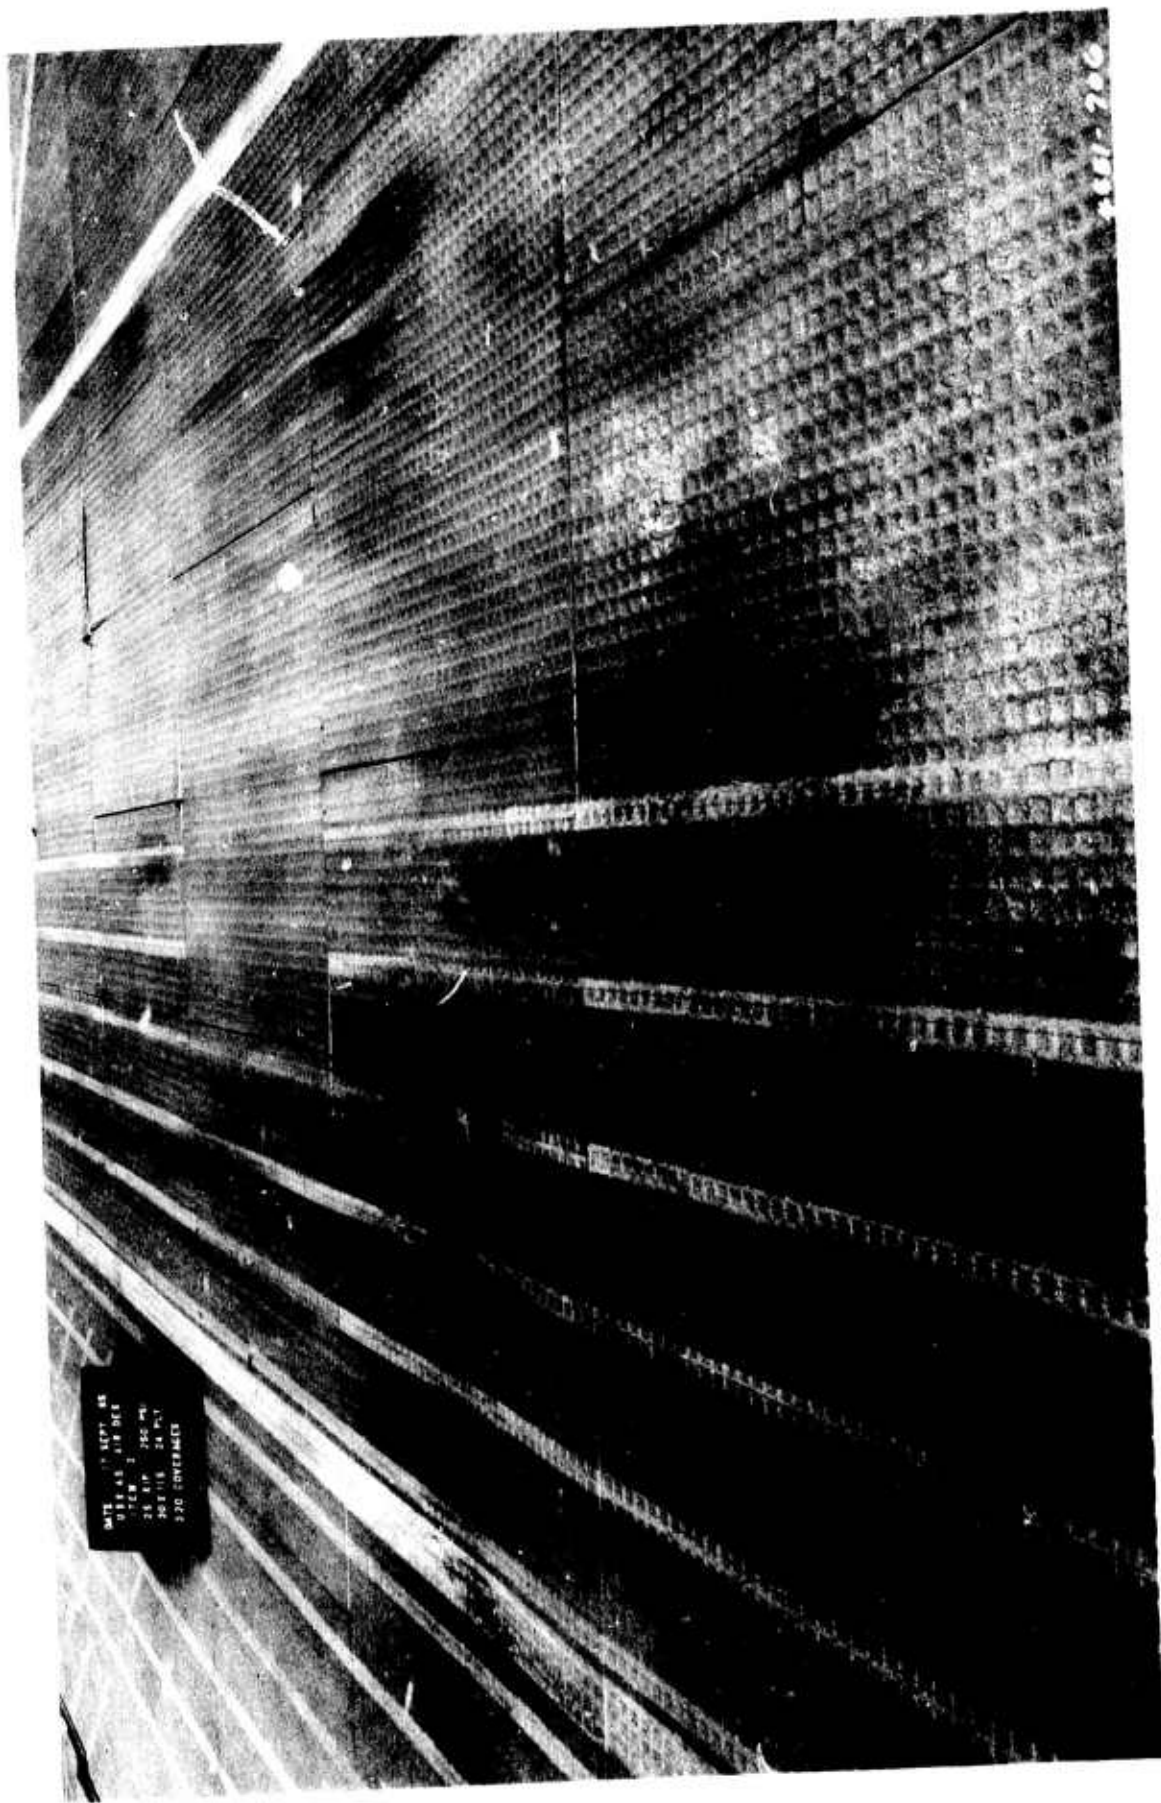
28. After 300 coverages of traffic on item 2, all mats with the Pittsburgh Chemical adhesive without primer were still serviceable; however, five panels were approaching failure (see photograph 19). The core along the edges of panels 37, 38, and 41 had crushed for a width of approximately 2 in. The mats containing the Pittsburgh Chemical adhesive with primer had one panel failed (panel 48) and one (panel 47) with two 6-in. cracks at completion of 300 coverages. The panels with low elongation and no primer in item 2 performed satisfactorily up to 300 coverages; however, panels 55 and 56 both had facing damage on the edges located adjacent to the approach area. Panels in this section were slightly heavier than the other two types of panels in this item.

Photograph 19. Overall view of item 2 after 300 coverages

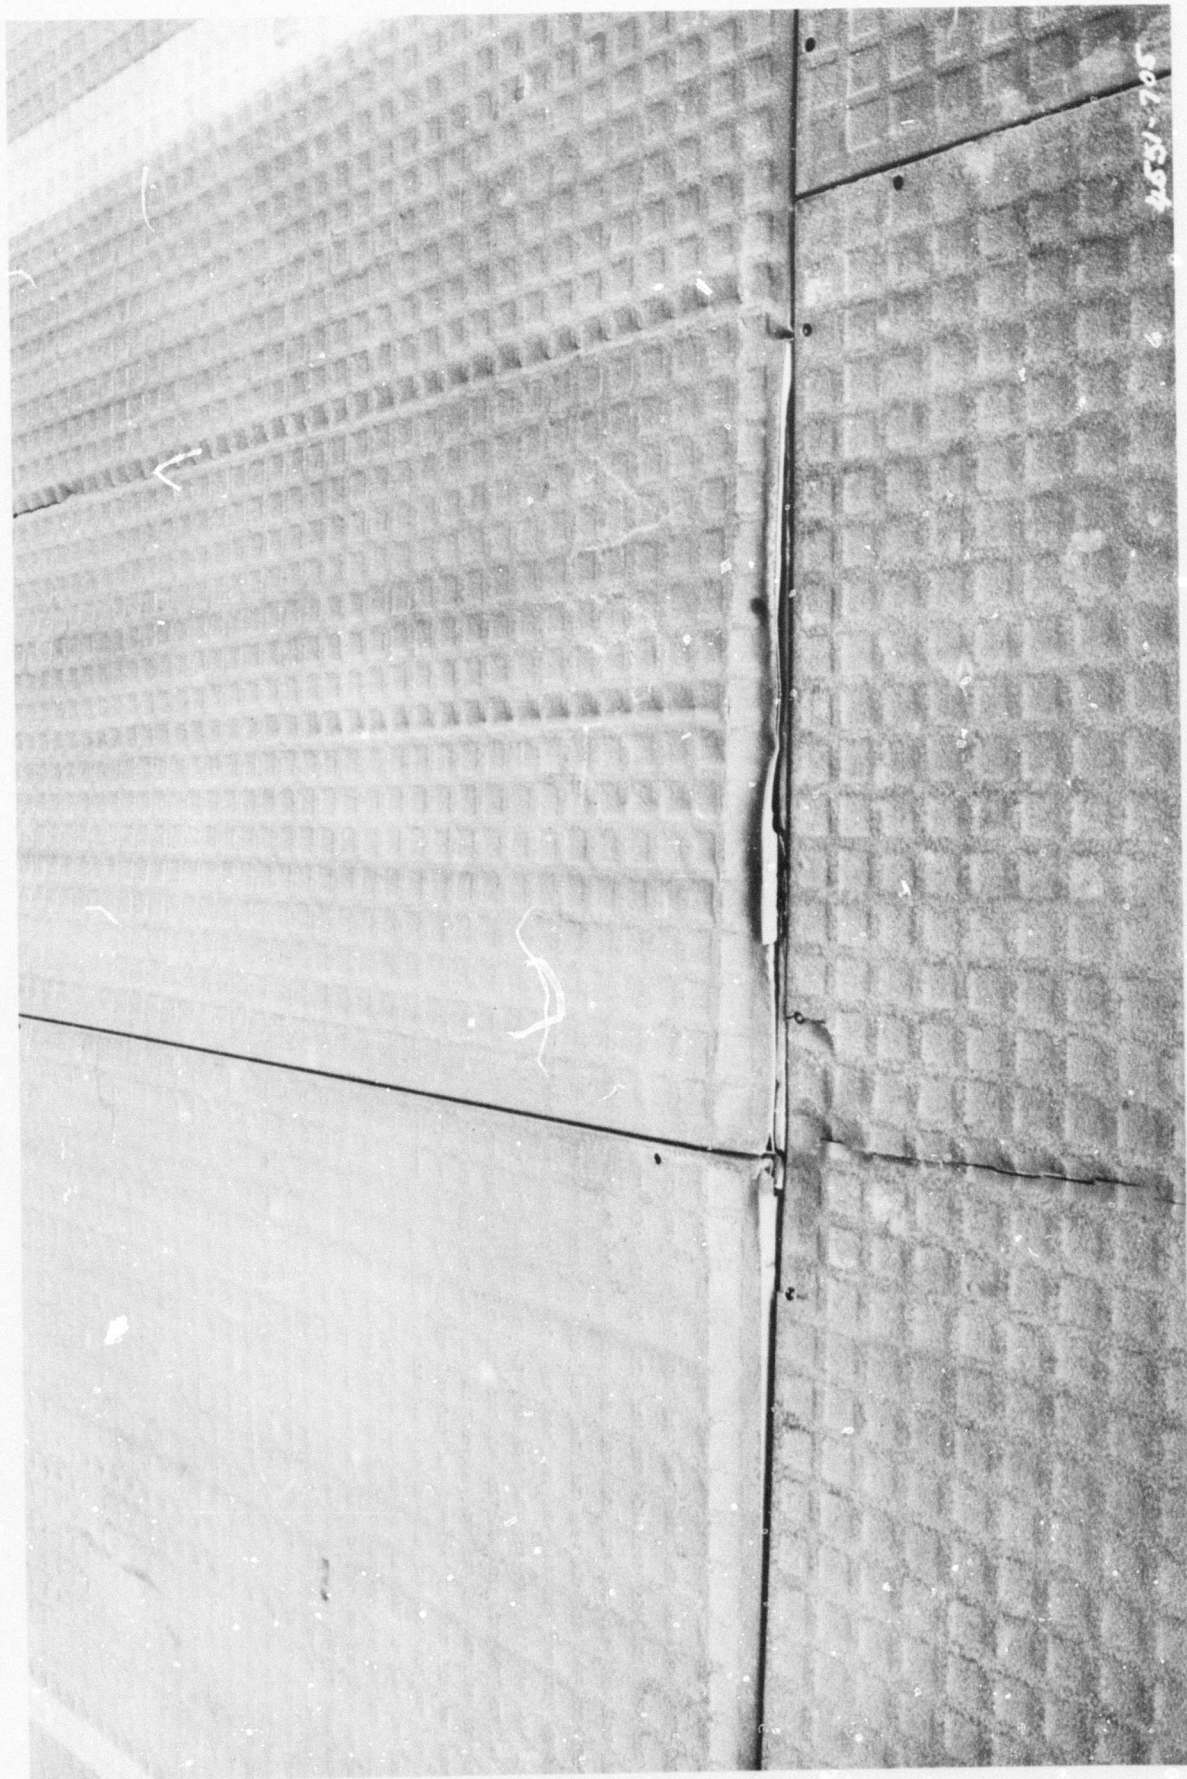
Photograph 20. General view of item 2 after 330 coverages
